How Good Design Can Protect the kārearea (New Zealand Falcon) and Improve Network Safety

EEA Conference & Exhibition 2017, 21 - 23 June, Wellington

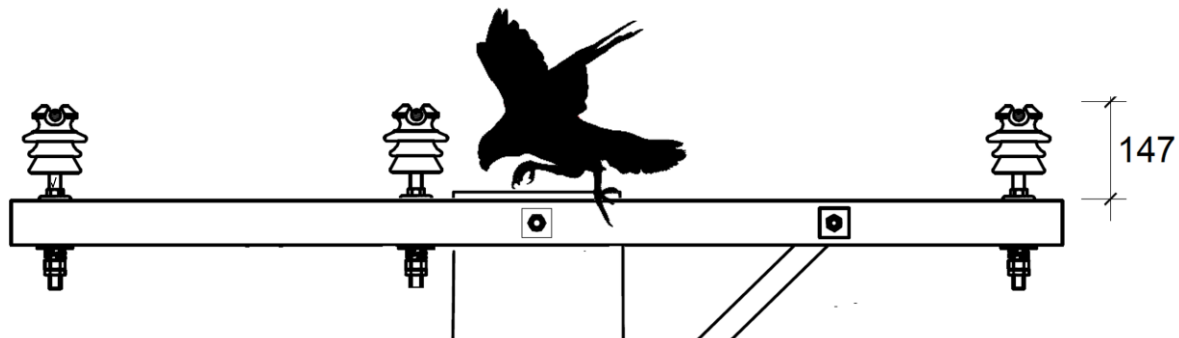
Figure 1: Legacy Inline Concrete Pole 1968 - Structure 37516 – 821 Insulators and 1.8m Wooden Crossarm

In the Marlborough study, [1][2] distribution transformer structures were involved in the majority of the tracked falcon deaths. In the Glenorchy study [4] transformer structures have also been involved as have cable terminations, a recloser and an inline structure. The implication that an inline structure (see Figure 1) could cause an electrocution was a concern given their ubiquity.

As can be seen from Figure 1, the size of the falcon next to the legacy 821 insulators demonstrates the risks on structures such as these. The top of the insulator is at 6350 volts to the head of the conductive concrete pole. In the case shown by figure 7 it is believed that the falcon was electrocuted by bridging the pole (its chest is at insulator neck height) and the binding wire around the top of the insulator to complete a circuit.

The height and offset of the 821 insulators from the head of the pole and small 1.8m crossarm are unfortunate.

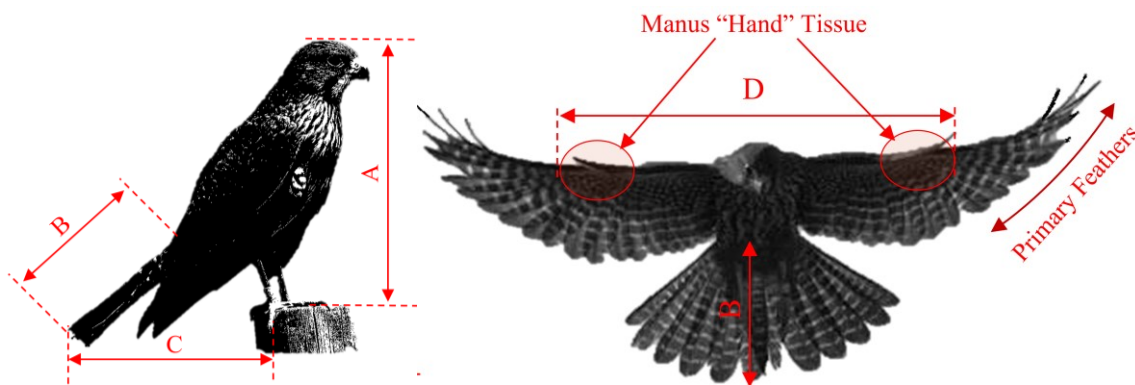
Figure 2: Bird Measurement Distances (See Definitions)

<i>Foot to Head (Perching)</i>	<i>Foot to Tail</i>	<i>Tail</i>	<i>Outer “Hand to Hand” (Manus Tissue)</i>	<i>Wing Length</i>	<i>Wing Span</i>
<i>Distance:</i>	<i>Figure 2</i>	<i>A</i>	<i>B</i>	<i>C</i>	<i>D</i>	<i>E</i>	<i>F</i>
<i>Female</i>	<i>Mean [μ]</i>	276	153	199	375	289	834
	<i>SD [σ]</i>	10	18	6	82	7	70
	<i>n</i>	8	8	7	7	9	7
<i>Male</i>	<i>Mean [μ]</i>	233	136	176	315	255	721
	<i>SD [σ]</i>	16	16	2	14	4	42
	<i>n</i>	2	2	2	2	2	2

$\mu+2\sigma$ (> 95 th Percentile)
<i>Foot to Head (Perching) (Figure 2 = A, n=8)</i>	296 mm
<i>Outer "Hand to Hand" (Manus Tissue) (Figure 2 = D, n=7)</i>	539 mm
<i>Centre Body to Outer "Hand" (Manus Tissue) (D/2)</i>	269 mm
<i>Foot to Chest (Perching) (2/3*A)</i>	197 mm

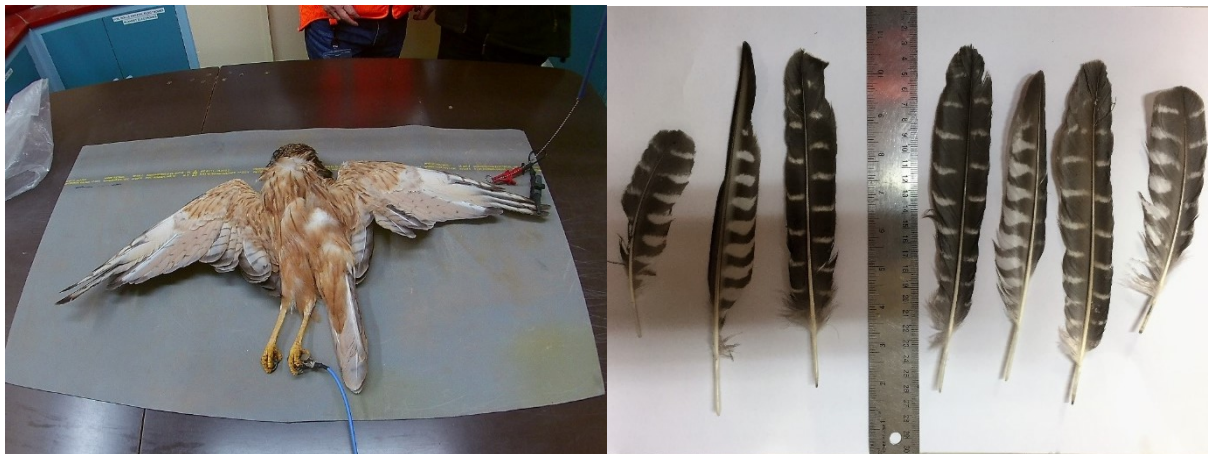
Figure 3: HV testing of kahu or Australasian hawk (*Circus approximans*) and karearea feathers (right).

To gauge the likely body resistance of a falcon, a fresh ‘road-killed’ Australasian harrier (*Circus approximans*) was tested in the high voltage laboratory at Delta. Foot to wing-tip (primary feathers), wing-tip to wing-tip and carpal tissue to foot leakage currents were all tested at voltages up to 6350V (the nominal line to ground voltage of an 11kV distribution system). These results are summarised in Table 4 below. As can be seen the resistance from the carpal tissue area is four orders of magnitude lower than the resistance involving the primary feathers; roughly 60,000 Ω . A second stage of testing was undertaken in which the primary flight feathers were removed and soaked in water for up to 30 minutes. This was also followed up with the soak testing of some karearea flight feathers borrowed from the Marlborough Falcon Conservation Trust (MFCT) Figure 3. These results are summarised in Table 5.

The results obtained above suggest that contact between a bird's flight feathers, away from any tissue, and a high voltage exposed live part would not likely lead to an injurious or fatal electric shock as the body current would be less than 1 mA. 1mA is two orders of magnitude less than that used to stun poultry. Tissue contact, however, between an exposed live part and earth or another phase should be considered potentially injurious or fatal. Dimensions therefore that include primary flight feathers are not as critical as those that involve tissue.

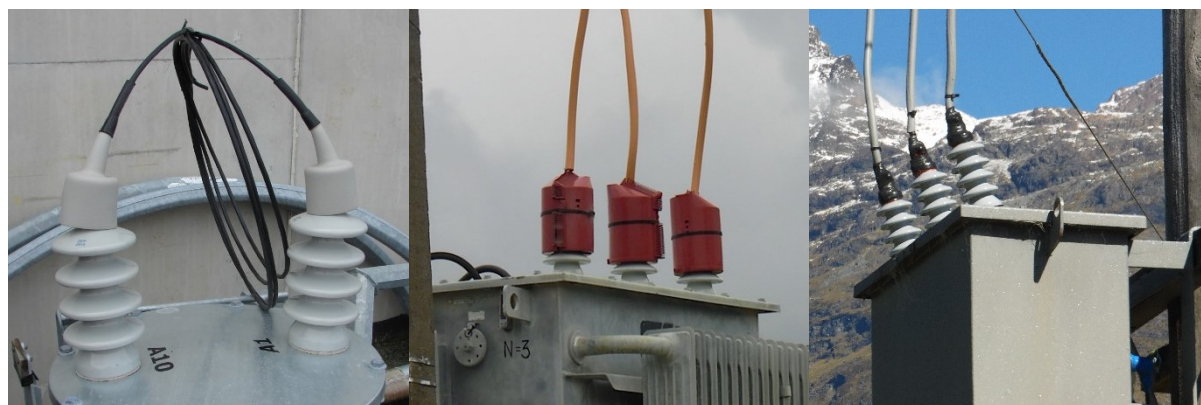
Figure 4: Examples of bushing coverings – Standard Practice (Dunedin), Tyco BCAC covers (Takaka), Medium Voltage Fusion Tape + PVC Tape GO11 (Glenorchy)

The taping or covering of bushings is considered a very effective way to reduce transformer risks. The use of bird guards (left Figure 4) is considered good as is the use of medium voltage fusion tape (MVFT). The hard retrofitted covers were found to be difficult to apply in Glenorchy with cables ties used to supplement their securement on surge arresters; cable ties are likely to have a limited life in such an environment. It is unclear at this stage how long fusion tape (MVFT) will remain adhered to the bushing before reapplication is required.

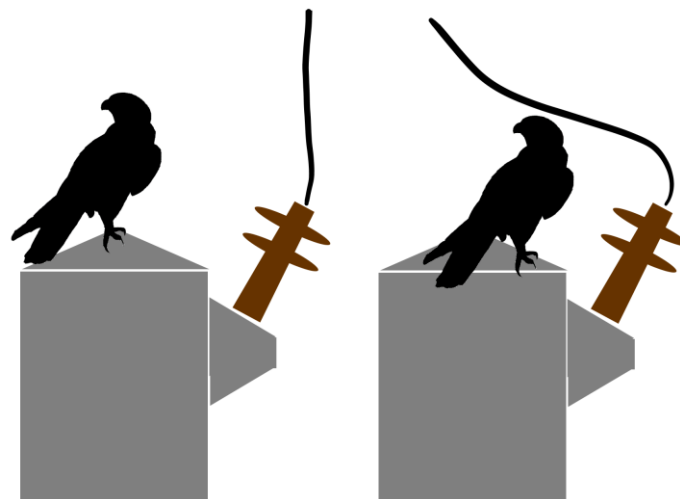
Figure 5: How repositioning or covering the HV droppers (black) can improve outcomes (porcelain bushings brown)

The consideration and design of droppers, including the items they supply (e.g. fuses and surge arresters), is therefore seen as vital in the process to assess and mitigate risks, especially where they are near platforms where falcons are likely to perch (e.g. transformer tank lids and crossarms).

Split tubing is typically used to cover bare dropper leads. We have found however, through recent testing, that PVC covered low voltage conductor (manufactured to AS/NZS 5000) had a consistent electrical strength of over 30kV. This testing used 6 sections of new conductor with 1 metre of their length immersed in a water bath. Our judgement backed up by many years of use is that such black PVC covered conductor is likely to retain adequate integrity for several decades against intermittent bird contact and UV damage at and below 11kV.

It is recommended that as a minimum, and until this or alternatives have been verified, all HV droppers use black PVC covered conductor with split-tubing used to supplement it where possible. Split tubing should always be used at higher voltages above 11kV as PVC covered conductor is unlikely to afford any safety factor.

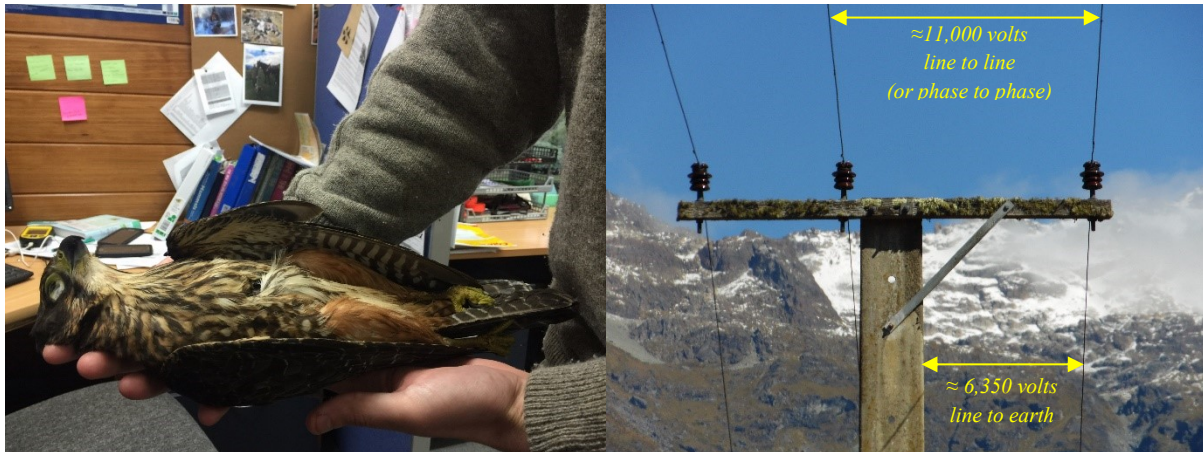
Figure 6: Electrocuted Falcon - Pole 37516 - 821 – Glenorchy – Chest, Leg and Talon Wounds

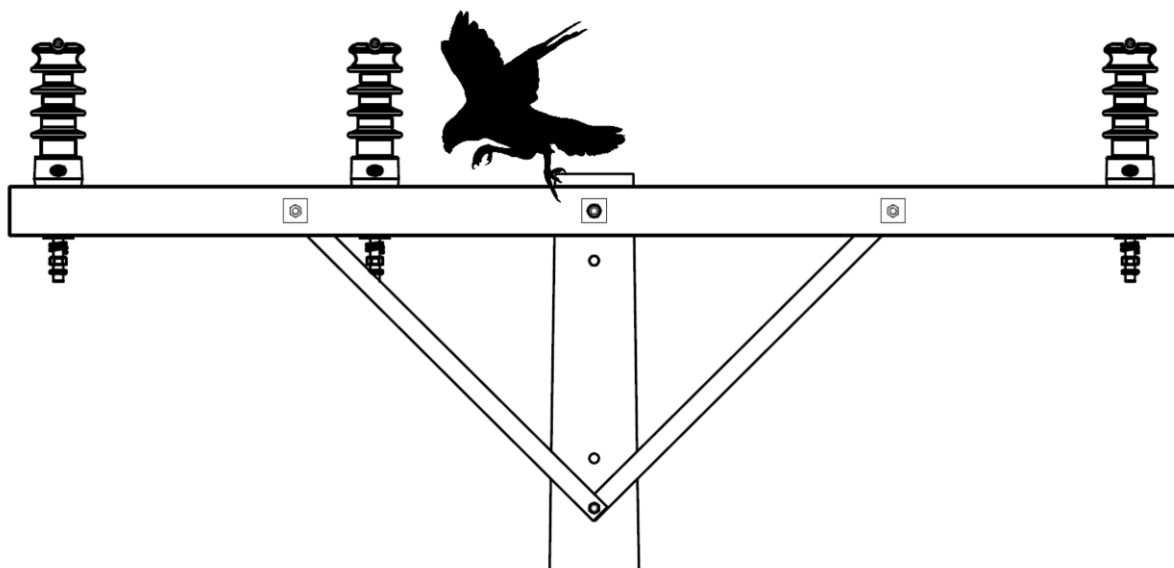
Figure 7: Modern 2.4m crossarm design with larger line post insulators

Based on physical measurements, it is unlikely for a falcon to bridge the 500 mm or so between two insulators/lines (phase to phase) with tissue-tissue (manus) contact. The legacy type of crossarm shown in Figure 6 is now being replaced with the design below affording improved clearances (Figure 7) and reduced electrocution risk.

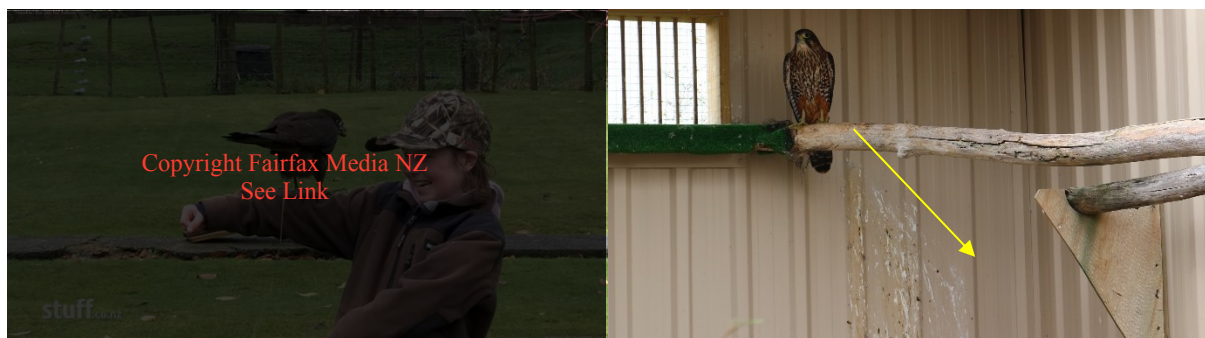
Figure 8: Example of Falcon ‘Streamer’ – “Hawkie” – Fairfax Media NZ – June 2016 [9] – MFCT Aviary Wall

Alongside eating, falcons have a related natural behaviour, that of excreting. As is clearly visible in Figure 8, faecal ‘streamers’ are of significant length and regularly between 300-500mm.

Should a conductive streamer be emitted by a falcon and bridge conductive parts then a fault current will flow and which could lead to a significant electric shock. The risks of such an event are heightened on conductive concrete or metal poles and crossarms and where fuses and droppers are located close to perches. Designers should consider the eventuality of such events and try to improve designs accordingly. The apparent preference for falcons to perch on lower conductivity crossarms (see above) as opposed to insulators, if real, reduces some of the likelihood of a streamer event between lines and an earthed structure.

As a guideline for discussion we proposed a maximum ‘streamer’ length of 500mm at an angle of 40° to vertical be considered.

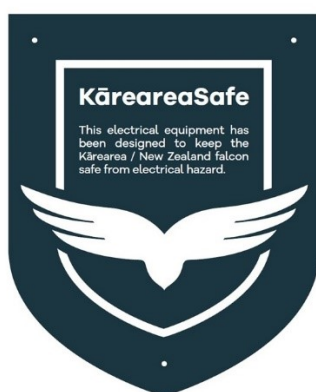
Figure 9: KāreareaSafe label planned to be installed on certified poles
